# ROOF MOISTURE SURVEYS AT PEASE AFB, NEW HAMPSHIRE, AND OFFUTT AFB, NEBRASKA

Lewis E. Link, Jr.

Mobility and Environmental Systems Laboratory  
U. S. Army Engineer Waterways Experiment Station  
P. O. Box 631, Vicksburg, Miss. 39180

January 1977  
Final Report

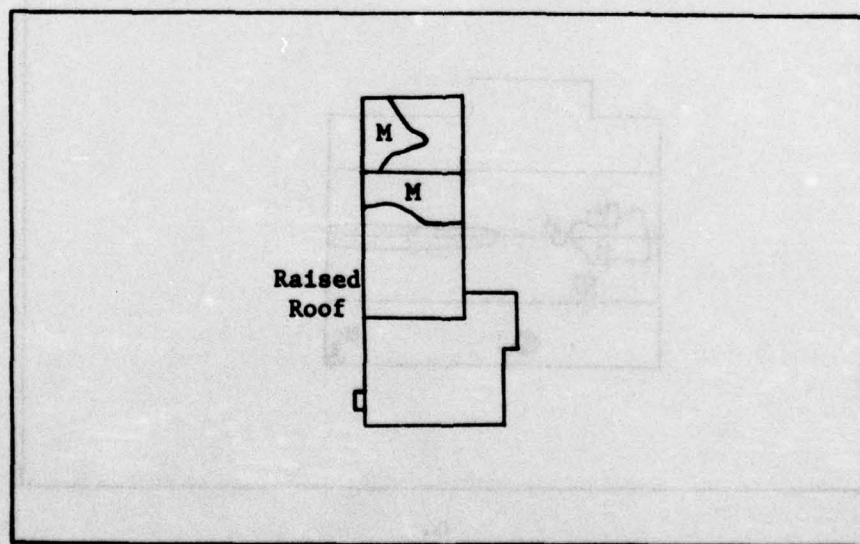
Figure 13. Thermal IR image (a) and identification of anomalies (b) for building No. 31, Pease AFB, New Hampshire

| <u>Building No.</u> | <u>Cause of Warm Anomalies</u> | <u>Remarks</u> |
|---|---|---|
| 31 | Entrapped moisture (two areas) | <u>Figure 13.</u> Moisture anomalies are quite evident on IR image; building boundaries are not always evident partially because of fogging of film |

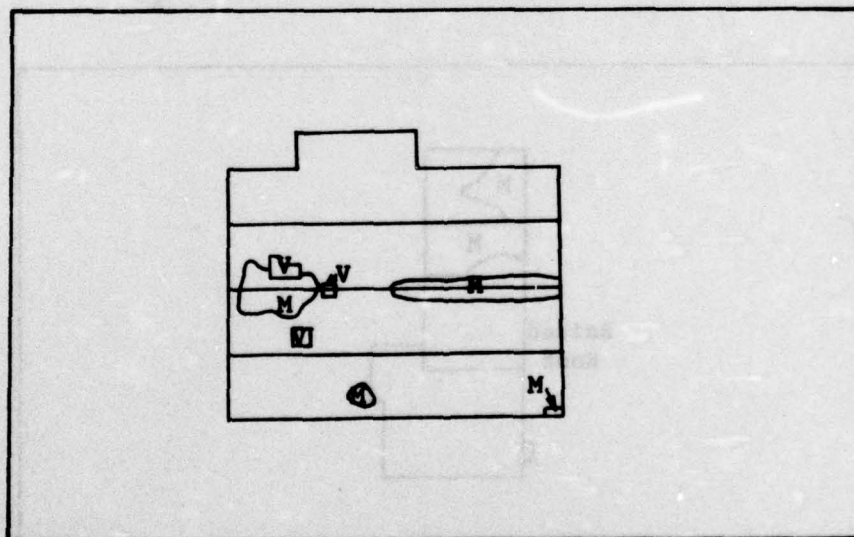
Figure 14. Thermal IR image (a) and identification of anomalies (b) for building No. 130, Pease AFB, New Hampshire

| <u>Building No.</u> | <u>Cause of Warm Anomalies</u> | <u>Remarks</u> |
|---|---|---|
| 130 | Entrapped moisture (four areas) | <u>Figure 14.</u> Moisture and vent anomalies are evident on IR image; small area of entrapped moisture located in south corner of building was not observable on imagery but was located with nuclear meter during detailed study |

Small wet area in south corner of building was found with the nuclear meter; it was not obvious on the imagery.

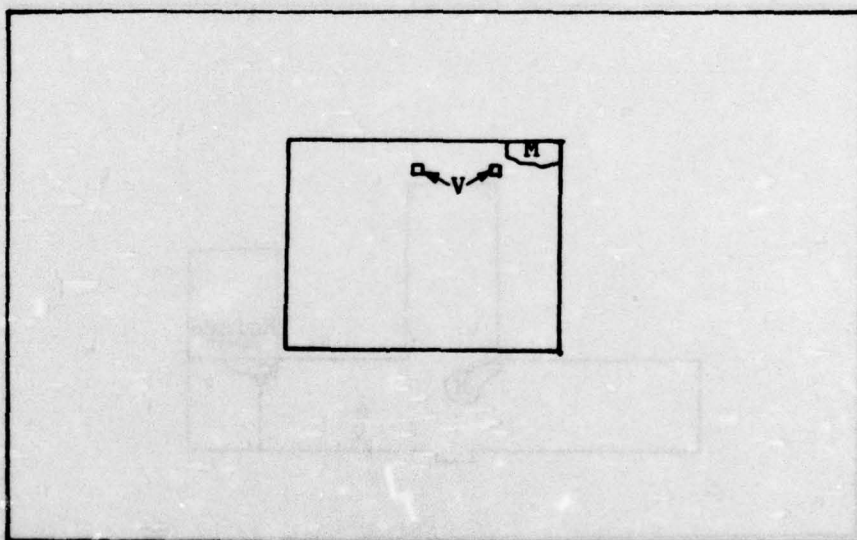
Figure 15. Thermal IR image (a) and identification of anomalies (b) for building No. 119, Pease AFB, New Hampshire

| <u>Building No.</u> | <u>Cause of Warm Anomalies</u> | <u>Remarks</u> |
|---|---|---|
| 119 | Entrapped moisture | <u>Figure 15.</u> One small area found with entrapped moisture; anomalies due to vents were easily identified as to source during image interpretation |

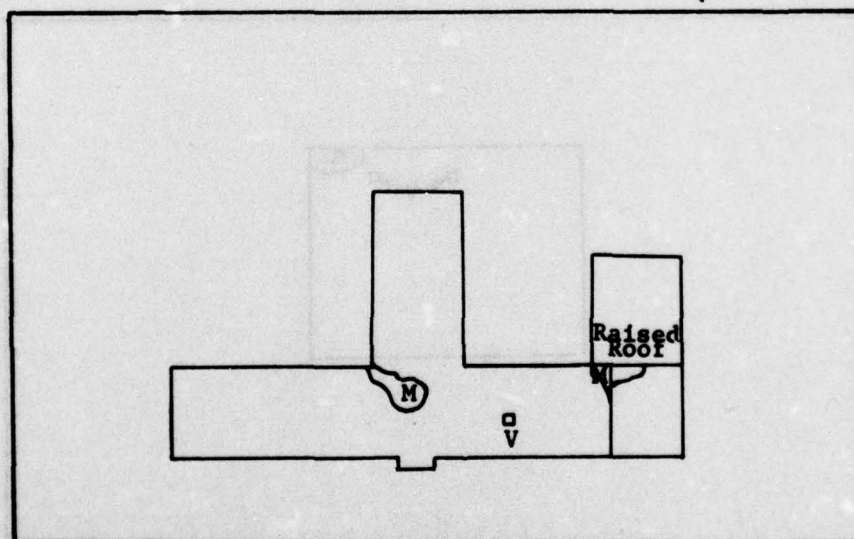
Figure 16. Thermal IR image (a) and identification of anomalies (b) for building No. 35, Pease AFB, New Hampshire

| <u>Building No.</u> | <u>Cause of Warm Anomalies</u> | <u>Remarks</u> |
|---|---|---|
| 35 | Entrapped moisture (two areas) | <u>Figure 16.</u> Building outline is difficult to determine without information on actual shape; moisture anomalies are very evident on imagery |

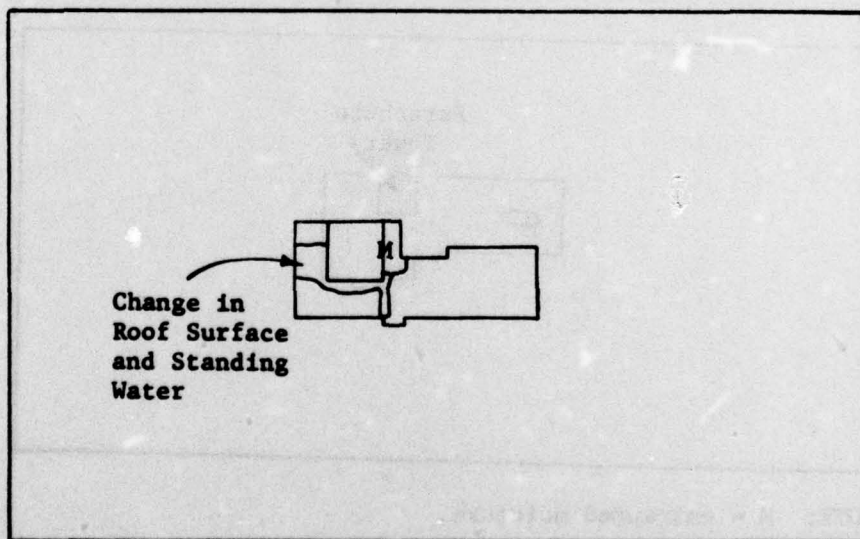
Figure 17. Thermal IR image (a) and identification of anomalies (b) for building No. 36, Pease AFB, New Hampshire

24. Standing water was a partial cause of an anomaly on the image of building No. 36. This emphasizes the fact that thermal IR imagery missions should not be flown when large areas of roofs are covered with standing water (e.g. immediately after a period of rainfall).

| <u>Building No.</u> | <u>Cause of Warm Anomalies</u> | <u>Remarks</u> |
|---|---|---|
| 36 | Entrapped moisture, roof surface change, standing water | <u>Figure 17.</u> Moisture anomaly is very evident on IR image; a warm anomaly (suspected at first to be caused by entrapped moisture) caused by a combination of a change in roof material characteristics (gravel color) and standing water |

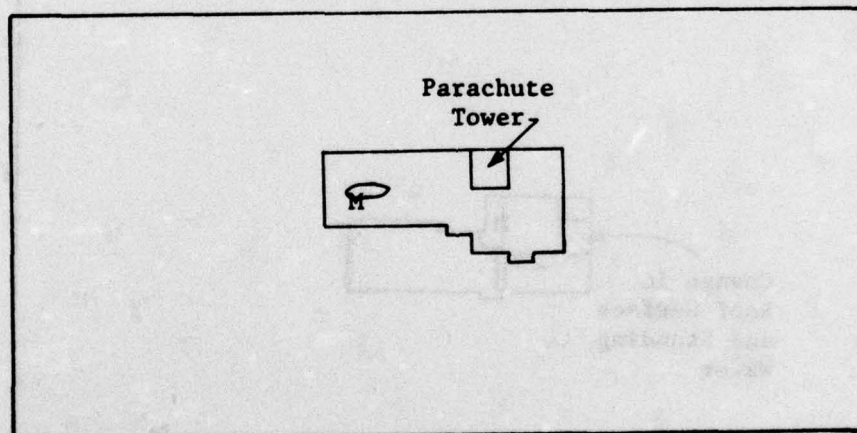
Figure 18. Thermal IR image (a) and identification of anomalies (b) for building No. 112, Pease AFB, New Hampshire

| <u>Building No.</u> | <u>Cause of Warm Anomalies</u> | <u>Remarks</u> |
|---|---|---|
| 112 | Entrapped moisture | <u>Figure 18.</u> Moisture anomaly is very evident on IR image; building outline is not easily discernable because of fog level on image |

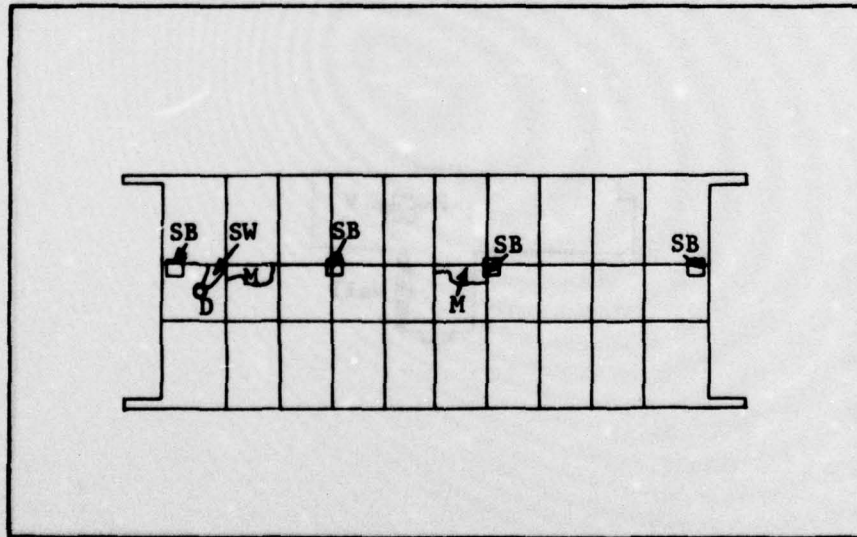
Figure 19. Thermal IR image (a) and identification of anomalies (b) for building No. 227, Pease AFB, New Hampshire

| <u>Building No.</u> | <u>Cause of Warm Anomalies</u> | <u>Remarks</u> |
|---|---|---|
| 227 | Entrapped moisture | <u>Figure 19.</u> Moisture anomalies are vague on blowup of image in figure but appear more clearly on original imagery negative; degradation in image quality is due to fog level and enlargement process |

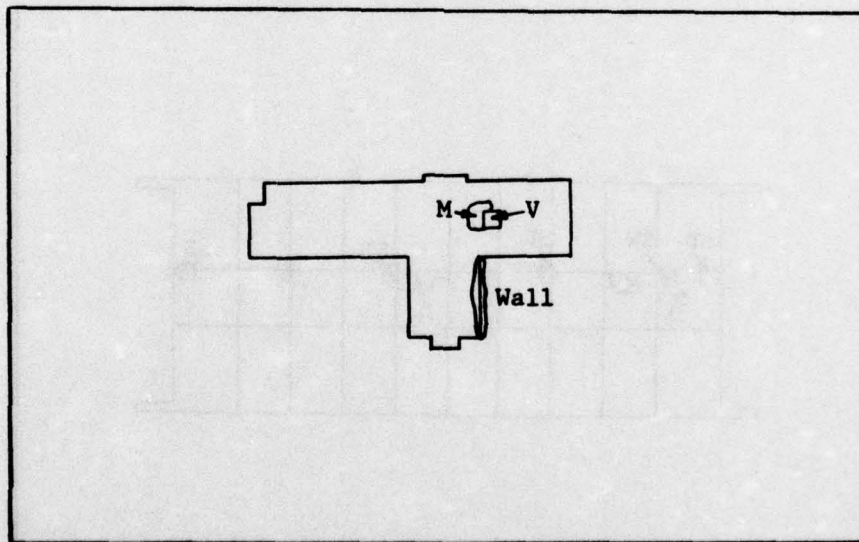
Figure 20. Thermal IR image (a) and identification of anomalies (b) for building No. 43, Pease AFB, New Hampshire

| Building No. | Cause of Warm Anomalies | Remarks |
|---|--|---|
| 43 | Entrapped moisture | <u>Figure 20.</u> Building outline is very difficult to delineate on IR image without prior knowledge of shape; moisture anomaly is evident after building outline determined |

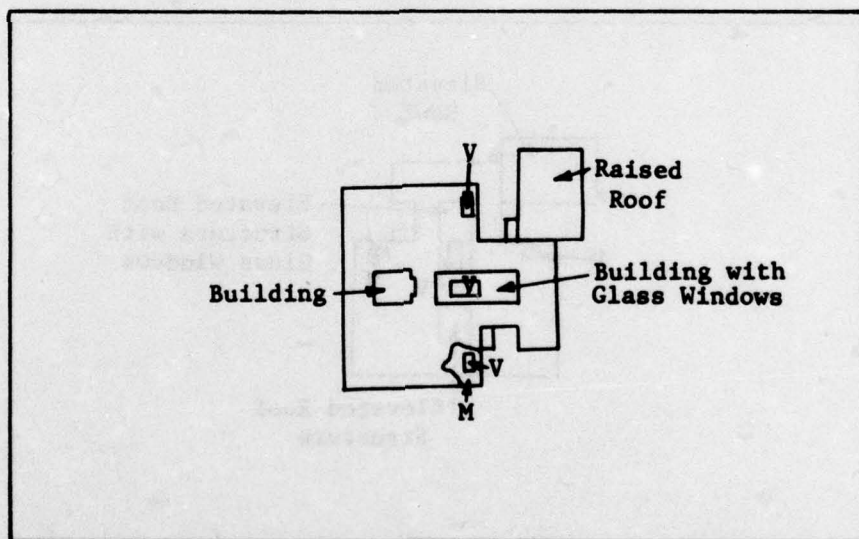
Figure 21. Thermal IR image (a) and identification of anomalies (b) for building No. 85, Pease AFB, New Hampshire

| Building No. | Cause of Warm Anomalies | Remarks |
|---|--|---|
| 85 | Entrapped moisture, elevated roof structures with vent windows | <u>Figure 21.</u> This building is an in-flight kitchen with elevated structures on the roof that have large windows. The walls of the elevated structures and hot-air vents from the windows created significant anomalies on the image. Prior knowledge of these conditions would have reduced the possibility of interpreting these anomalies as possible areas with entrapped moisture. One area with entrapped moisture was identified correctly |

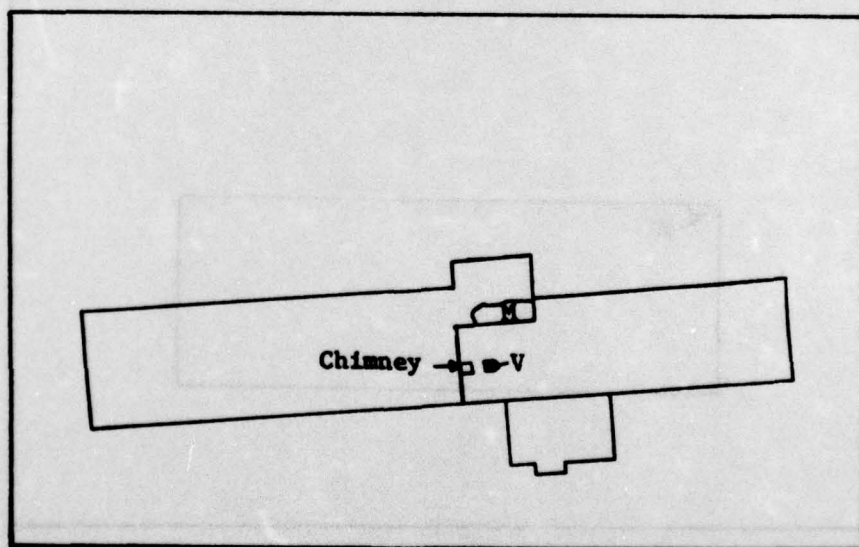
Figure 25. Thermal IR image (a) and identification of anomalies (b) for building No. 38, Pease AFB, New Hampshire

| Building No. | Cause of Warm Anomalies | Remarks |
|---|--|---|
| 38 | Entrapped moisture | <u>Figure 25.</u> Building outline is somewhat difficult to delineate on enlarged image but more easily identified on original negative; entrapped moisture anomaly is evident on IR image |

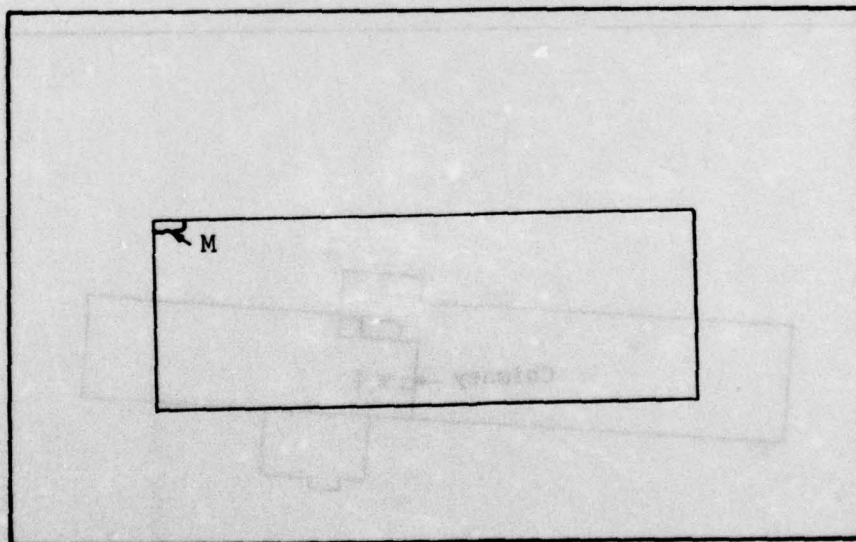
Figure 26. Thermal IR image (a) and identification of anomalies (b) for building No. 120, Pease AFB, New Hampshire

| Building No. | Cause of Warm Anomalies | Remarks |
|---|--|---|
| 120 | Entrapped moisture | <u>Figure 26.</u> Area with entrapped moisture is quite small and does not show up well on enlarged image in the figure, but it is evident on original negative of IR imagery |

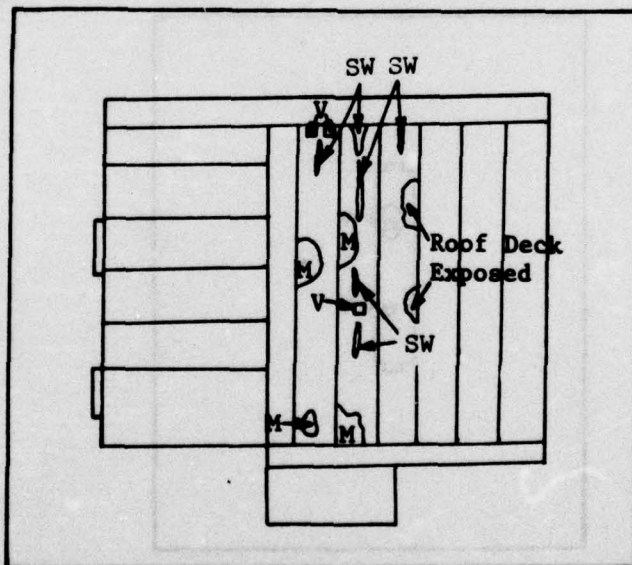
Figure 27. Thermal IR image (a) and identification of anomalies (b) for building No. 301, Offutt AFB, Omaha, Nebraska

| Building No. | Cause of Warm Anomalies | Remarks |
|---|---|---|
| 301 | Entrapped moisture; roof surface change | <u>Figure 27.</u> Only the three bays on which anomalies are outlined in the figure were surveyed in detail. Moisture anomalies are quite evident on the IR imagery. Anomalies designated as "roof surface change" are areas where the insulation and deck of the roof are exposed |

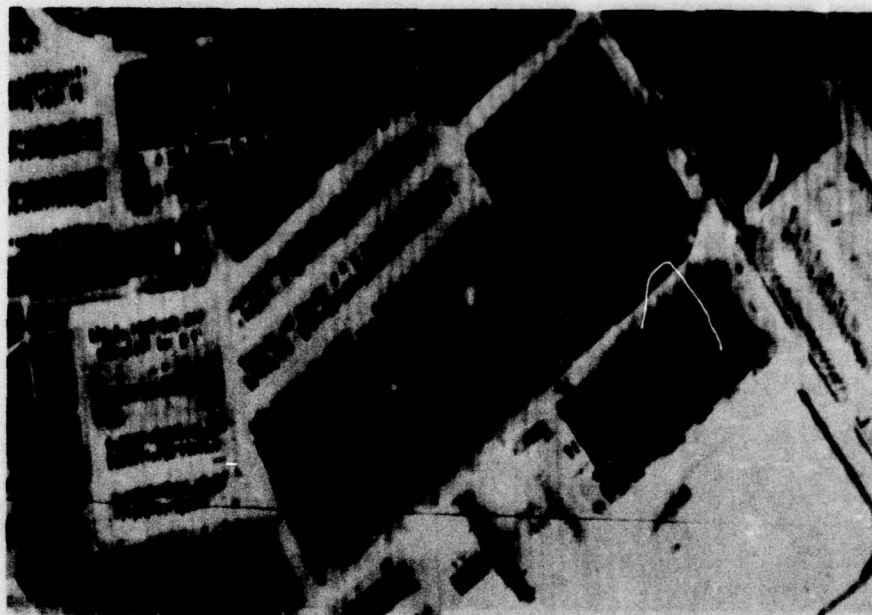
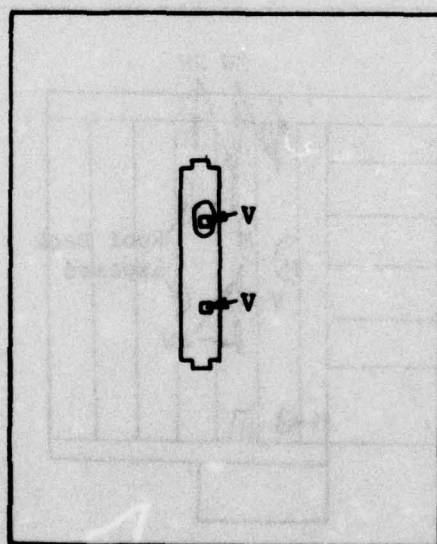
Figure 28. Thermal IR image (a) and identification of anomalies (b) for building No. 526, Offutt AFB, Omaha, Nebraska

| Building No. | Cause of Warm Anomalies | Remarks |
|---|---|---|
| 526 | Air vents | <u>Figure 28.</u> Anomaly identified during the detailed study to be caused by air vent is not readily visible on the enlargement in the figure, but it does appear on the original IR negative |

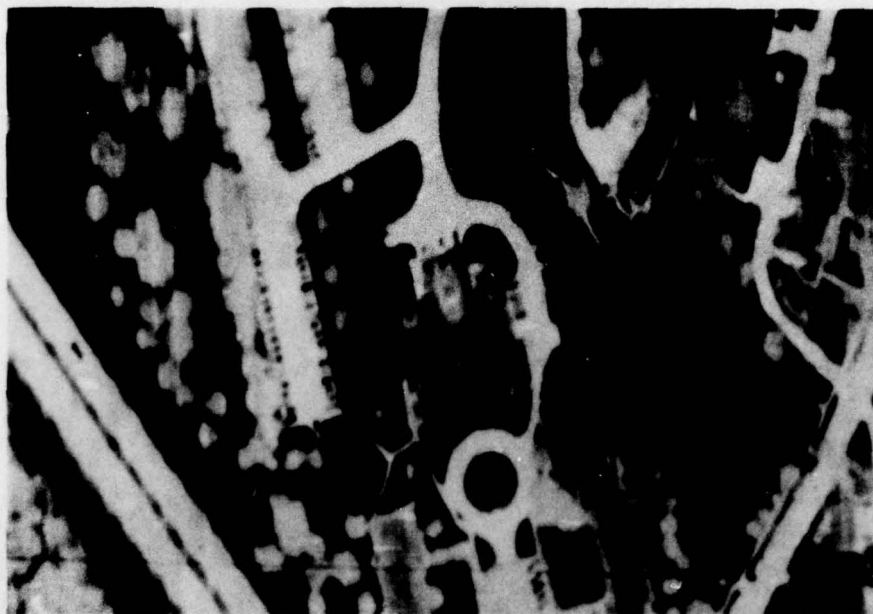
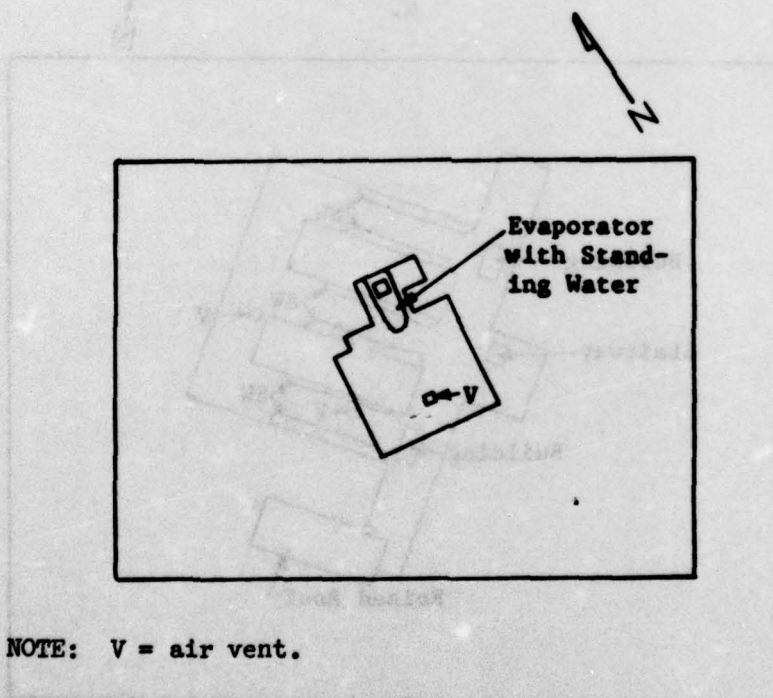
Figure 29. Thermal IR image (a) and identification of anomalies (b) for building No. 418, Offutt AFB, Omaha, Nebraska

| Building No. | Cause of Warm Anomalies | Remarks |
|---|---|---|
| 418 | Evaporator and standing water | <u>Figure 29.</u> Anomaly suspected to be caused by entrapped moisture was due to a large evaporator on the roof and some associated standing water on the roof around it. This anomaly would have been less likely to be identified as entrapped moisture if the interpreter had had prior knowledge of the presence of the evaporator |

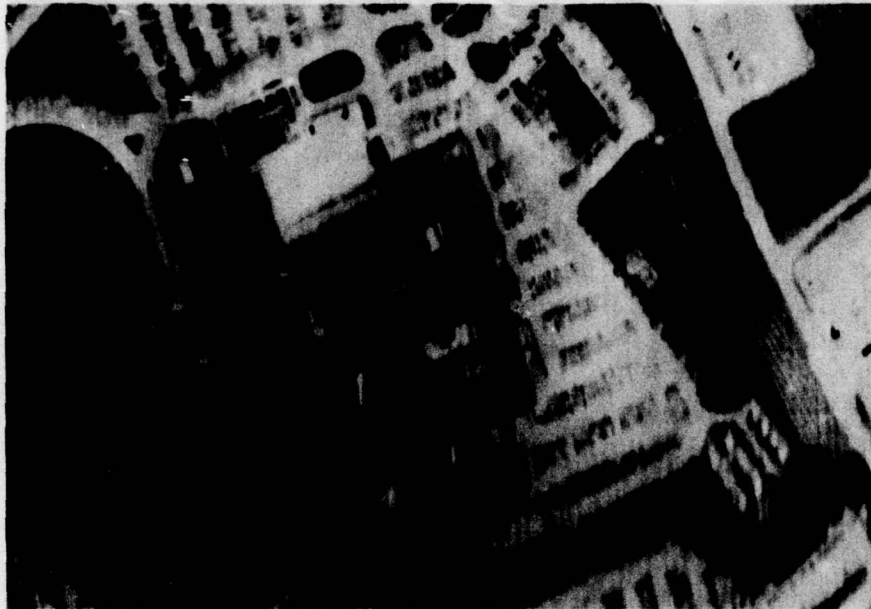
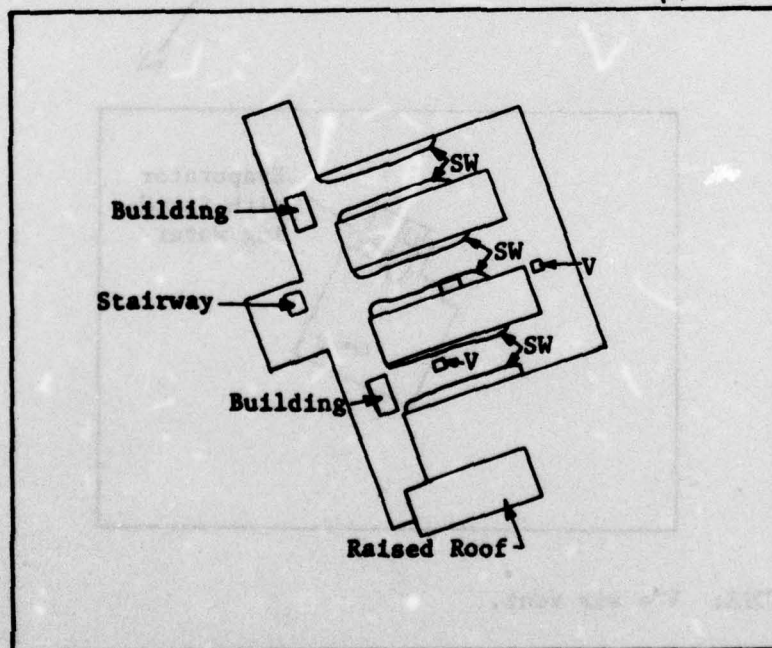
Figure 30. Thermal IR image (a) and identification of anomalies (b) for building No. 500, Offutt AFB, Omaha, Nebraska

| Building No. | Cause of Warm Anomalies | Remarks |
|---|---|---|
| 500 | Standing water | <u>Figure 30.</u> Areas suspected to have entrapped moisture are slight depressions and had significant standing water. Spot checks with the nuclear meter did not reveal any entrapped moisture |

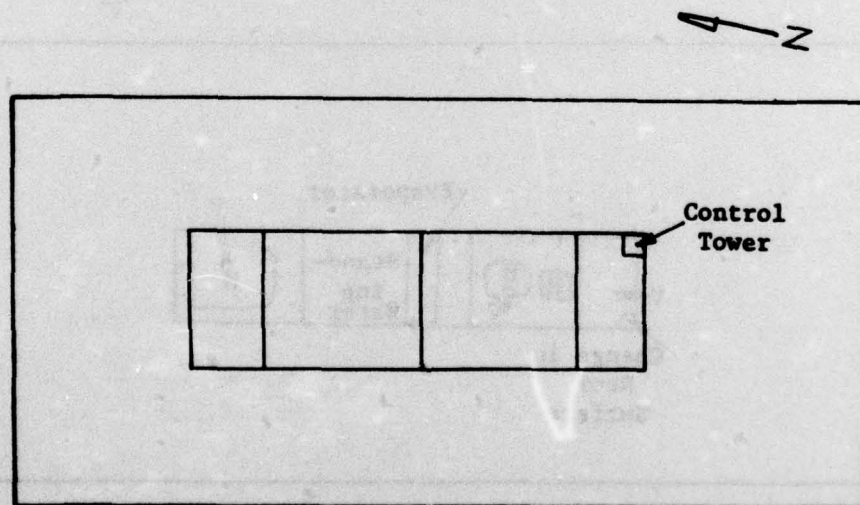
Figure 31. Thermal IR image (a) and identification of anomalies (b) for building No. 306, Offutt AFB, Omaha, Nebraska

| Building No. | Cause of Warm Anomalies | Remarks |
|---|---|---|
| 306 | Elevated roof structure (control tower) | <u>Figure 31.</u> Anomaly suspected to be entrapped moisture was due to a control tower on the roof. This "false alarm" would have been averted if the interpreter had been aware of the presence of this feature on the roof |

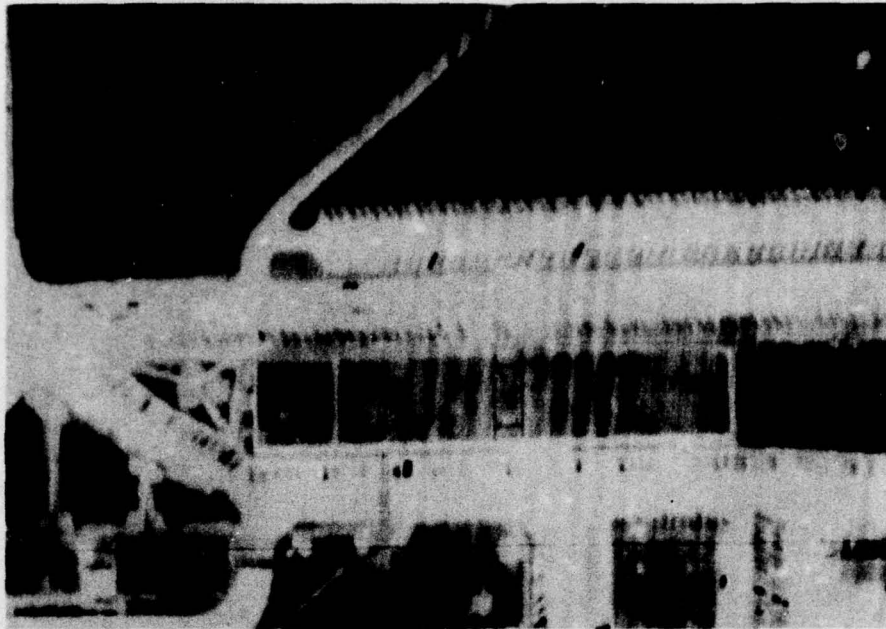
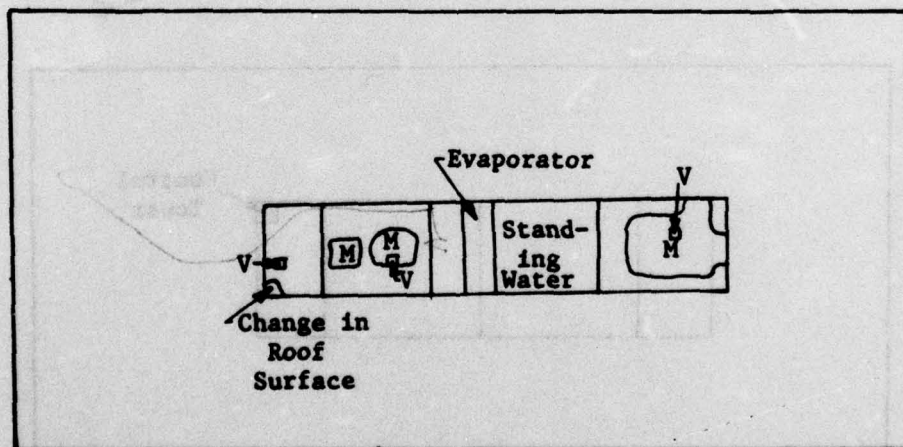
Figure 32. Thermal IR image (a) and identification of anomalies (b) for building No. 323, Offutt AFB, Omaha, Nebraska

| Building No. | Cause of Warm Anomalies | Remarks |
|---|--|---|
| 323 | Entrapped moisture (three areas), standing water, change in roof surface | <u>Figure 32.</u> Some scan-line noise is evident on the image (in the figure), which degraded the interpretability of the image to some extent. Moisture anomalies are more obvious on the original IR imagery negative than on the enlargement in the figure. Anomalies due to some standing water were evident as well as a small anomaly due to a change in the gravel surface (mostly color) |

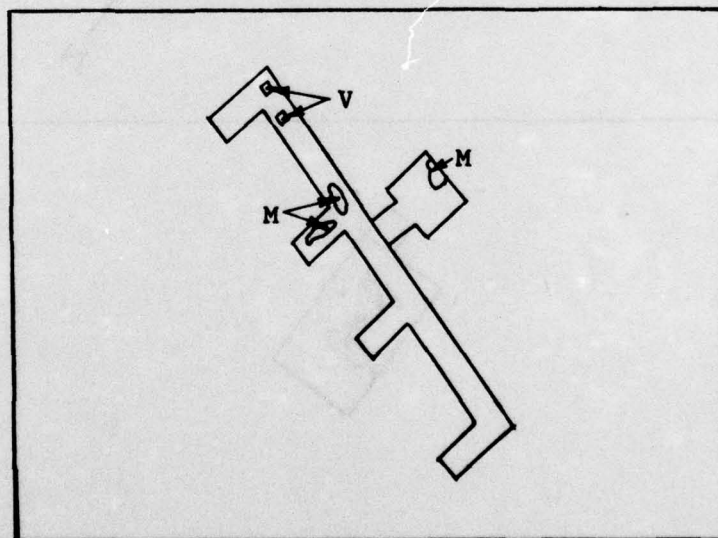
Figure 33. Thermal IR image (a) and identification of anomalies (b) for building No. 324, Offutt AFB, Omaha, Nebraska

| Building No. | Cause of Warm Anomalies | Remarks |
|---|--|---|
| 324 | Entrapped moisture (three areas), vents | <u>Figure 33.</u> Moisture anomalies are evident on IR imagery; some small anomalies created by vents originally suspected to be caused by entrapped moisture. Southern portion of the building has new roof and presents a good example of the uniform dark tone that is representative of a good roof |

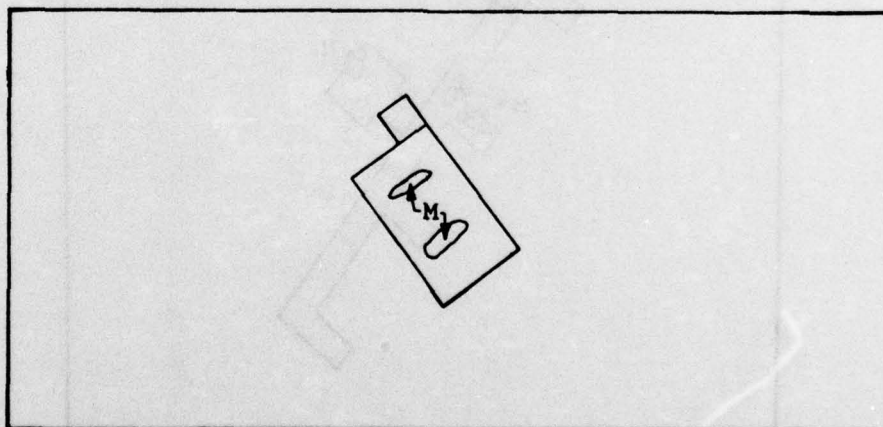
Figure 34. Thermal IR image (a) and identification of anomalies (b) for building No. 407, Offutt AFB, Omaha, Nebraska

| Building No. | Cause of Warm Anomalies | Remarks |
|---|--|---|
| 407 | Entrapped moisture (two areas) | <u>Figure 34.</u> Moisture-induced anomalies are evident on the IR imagery |

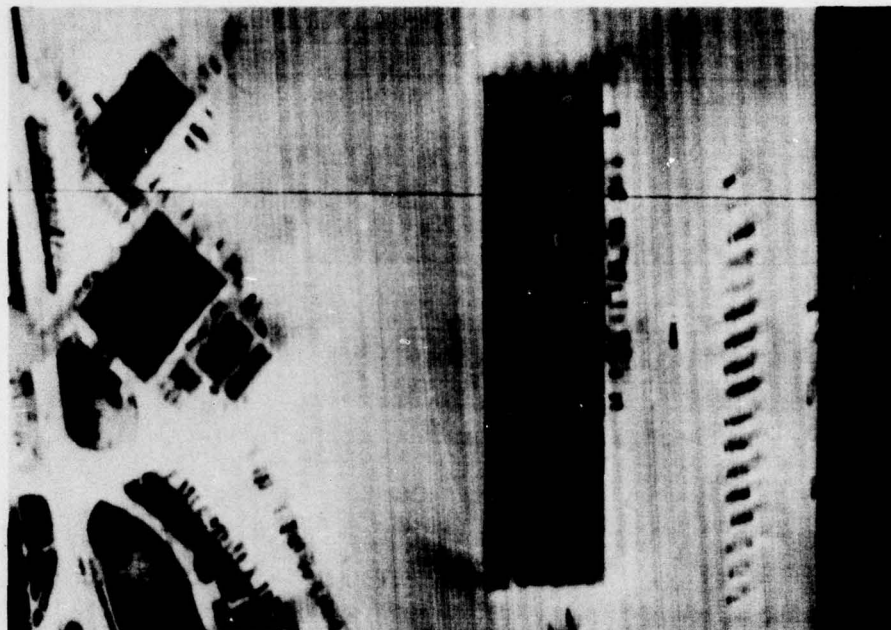
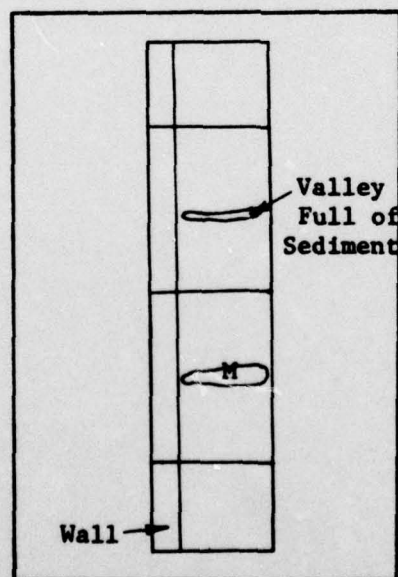
| Building No. | Cause of Warm Anomalies | Remarks |
|---|--|---|
| 307 | Entrapped moisture, valley with sediment buildup | <u>Figure 35.</u> Entrapped moisture anomaly is evident on the IR imagery. Anomaly on north section of roof is due to a valley (the roof has two major peaks) filled with fine materials washed off higher portions of the roof |
